[Technical Report]

**IMPLEMENTATION AND SUPERVISION PROJECT FOR THE SUPPLY
AGENCY OF INTEGRATED PUBLIC SERVICES, KOMBINAT, TIRANA.
REF. AL-8521-CS/CQ/2.05.08**

**ARCHISPACE SHPK
STUDIO-REBUS SHPK**

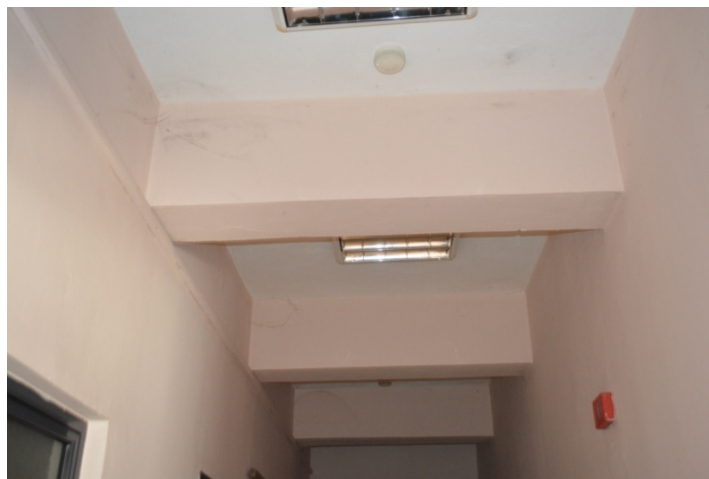
- The height of the existing ground floor is 340 cm, floor to ceiling.
- The building has a structural construction of retaining walls and hanging beams which are noticeable along the ceilings of all the existing spaces. The retaining walls are located in the perimeter of the ground floor and the middle spaces that they create, with a depth of 50 cm. The stair core works as part of the existing structure.

Photo 6 _The hanging beams of the building

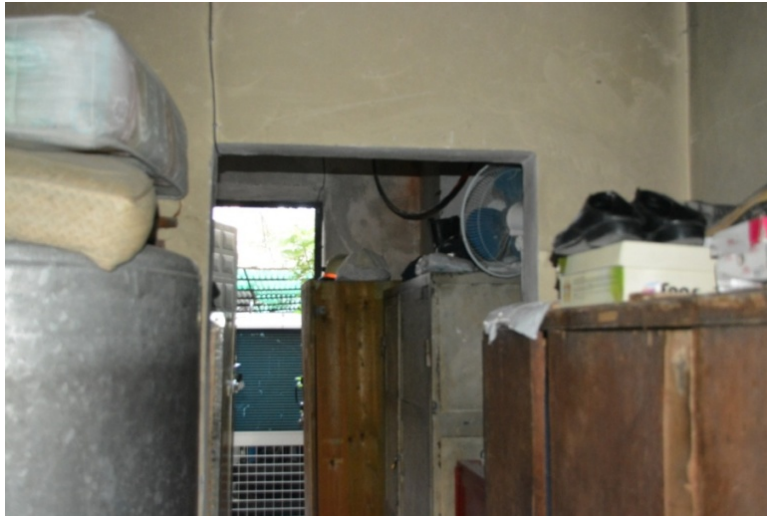
- The spaces located in the west wing of the building have a lot of humidity coming in from the ceiling and the side walls. The humidity is more present in the toilets areas and the boiler's room. Actually humidity can be easily seen in many parts of the existing rooms but, the mentioned above areas, have more humidity compared to the other ones.

Photo 7_Humidity in the boiler room

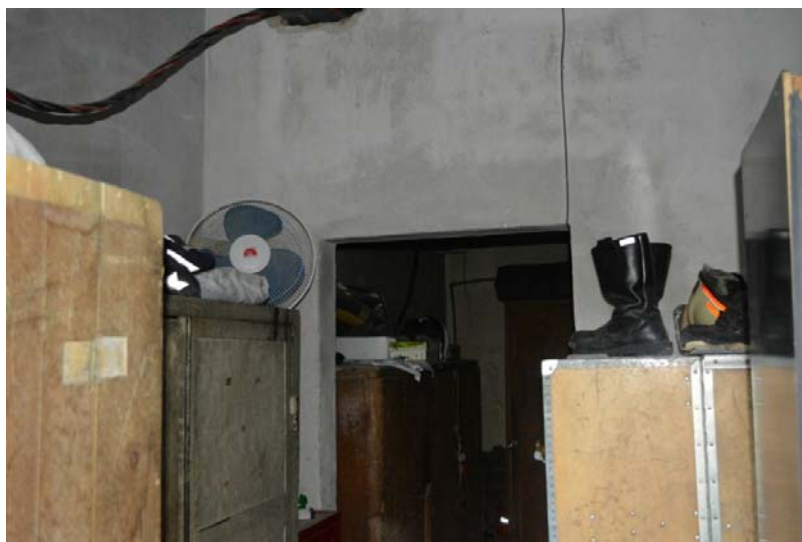
- The main boiler room is currently not functional. This issue has "forced" the use of air conditioning in many rooms used by the staff of the municipality unit.

The boiler room space is not only not functional but is the most sensitive part of the building regarding the outside atmospheric agents because of the lack of plaster works, hydro insulation and thermo insulation (it can easily be seen in the photos below). Today this space is mainly used as a storage of old and unused materials. This area can be accessed not only by the inside spaces but also by the outside surrounding areas with a maintenance door.

Photo 8_Usage of the boiler room spaces

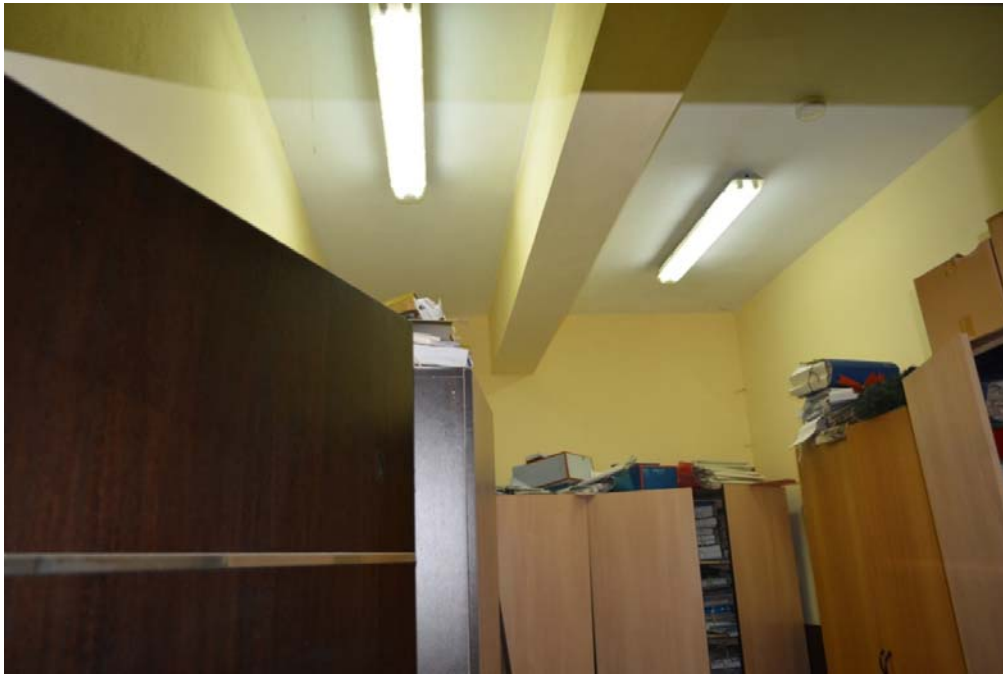
-
- In the boiler room is also located the main electrical panel. This panel serves for the two floors of the building. From a preliminary analysis of the existing electric panel, it needs to be repaired and maybe divided for the two floors of the building.
 - The water tanks of the building are located nearby the boiler room, and serve to access the boiler room from the inside of the building. This room is one of the main reasons of the existing humidity in the building
 - The existing archive space is filled with unorganized files and has a lack of lightening

Photo 8_Existing archive
