[Technical Report]

**IMPLEMENTATION AND SUPERVISION PROJECT FOR THE SUPPLY
AGENCY OF INTEGRATED PUBLIC SERVICES, KOMBINAT, TIRANA.
REF. AL-8521-CS/CQ/2.05.08**

**ARCHISPACE SHPK
STUDIO-REBUS SHPK**

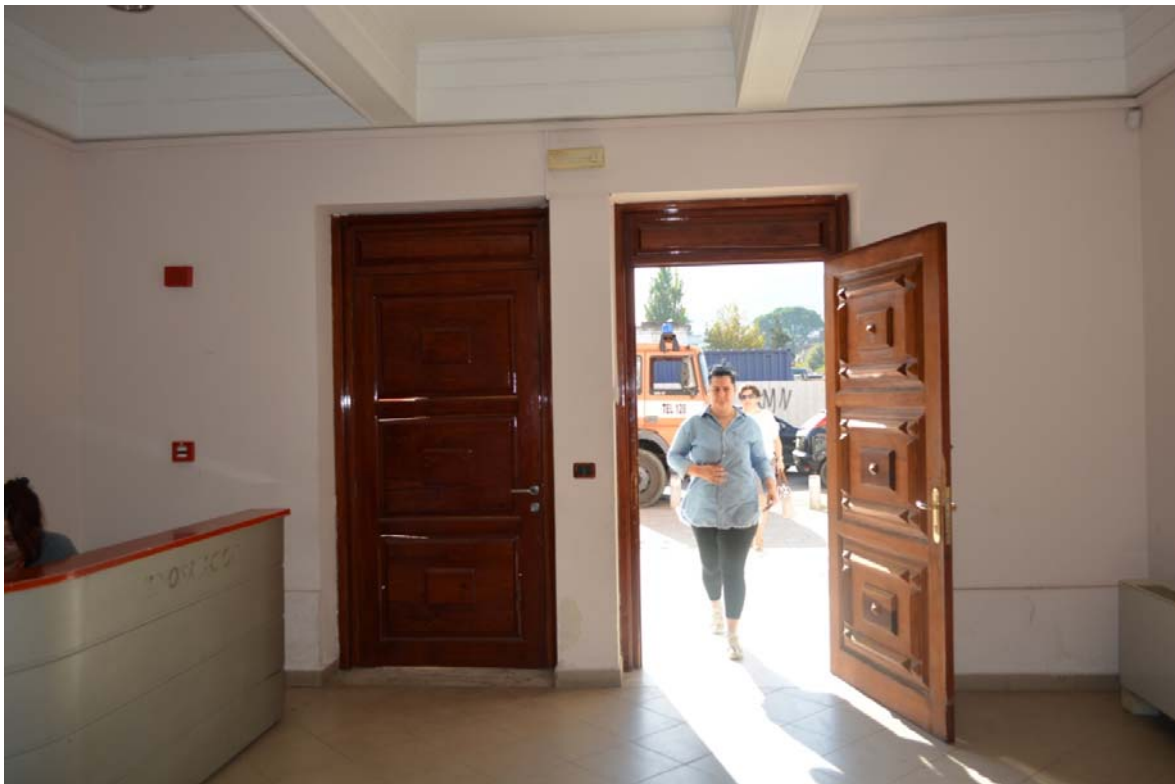
Photo 3_Main entrance

The building in its ground floor has a main entrance with two wooden doors, which distributes the public to the existing spaces and functions of the municipality unit.

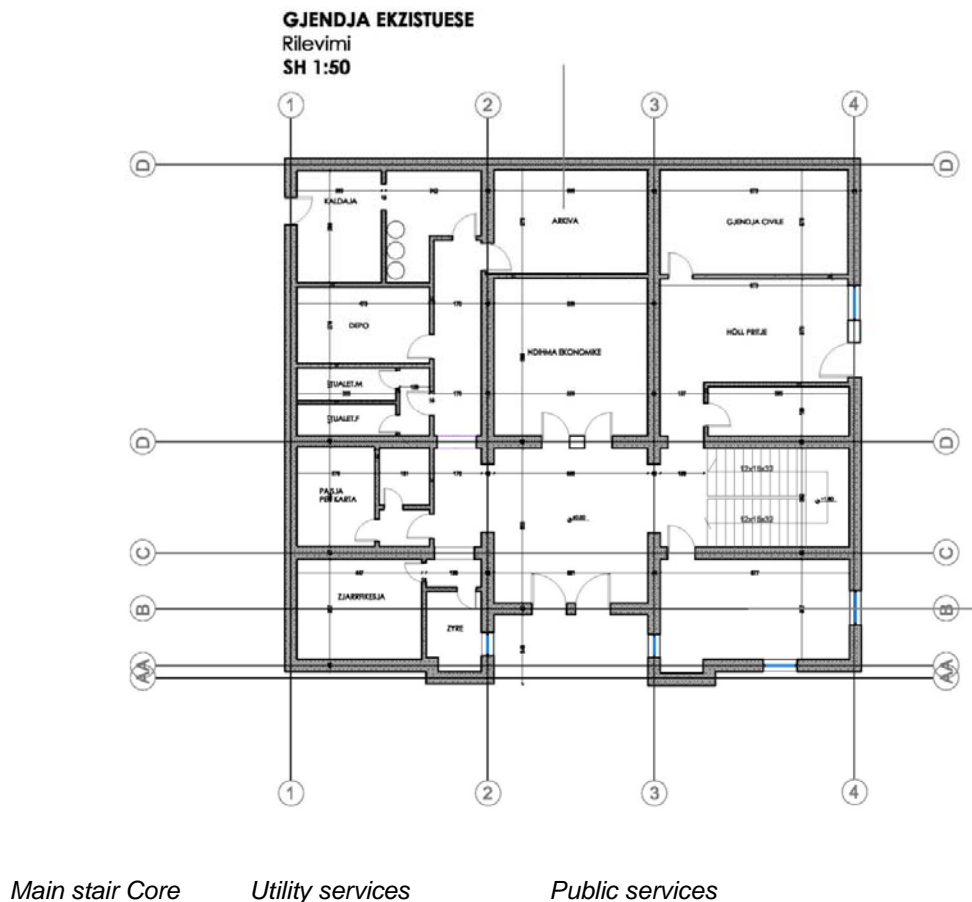
Photo 4_Functional scheme of the existing building

According to the main functional scheme of the existing building, as shown in the Photo no. 4, we will notice that the west wing is used for the utility services of the building such as:

boiler room, toilets, storage room, archive etc. While in the eastern wing of the building are located the main public services such as: the reception, civil status spaces etc

All the spaces located in the west wing are connected by a main corridor of 1.7 meters, which has no natural light but has longitudinal LED lighting. The LED lightings are positioned between the main beams of the corridor.

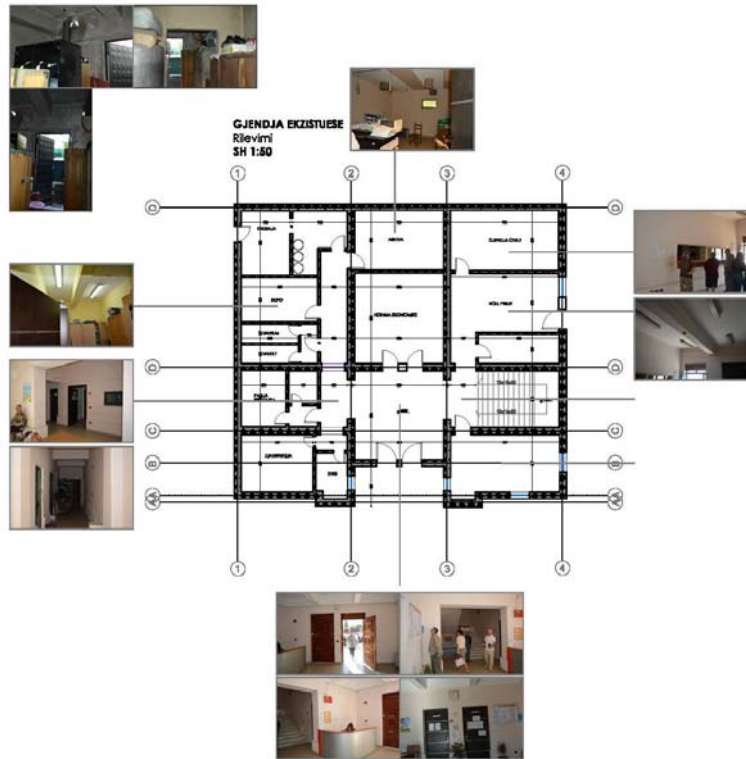
Photo 5 _The building's existing plan and photos of each space

The building has windows in its eastern and southern facade which allow the natural light in. The other parts of the spaces have no natural light but instead the amount of the necessary light is replaced by LED lighting.
